FACILITY CONDITION ASSESSMENT SALTAIR COMMUNITY CENTRE

3850 South Oyster Road, Ladysmith British Columbia

Prepared for:	Austin Tokarek, Asset Coordinator Engineering Services Department Cowichan Valley Regional District 175 Ingram Street Duncan, BC V9L 1N8
Prepared by:	McCuaig & Associates Engineering Ltd. #201 – 33 East 8th Avenue Vancouver, BC V5T 1R5
Date:	July 21, 2017
McCuaig Ref.:	20170401-C-RPT-FCA-01-FNL

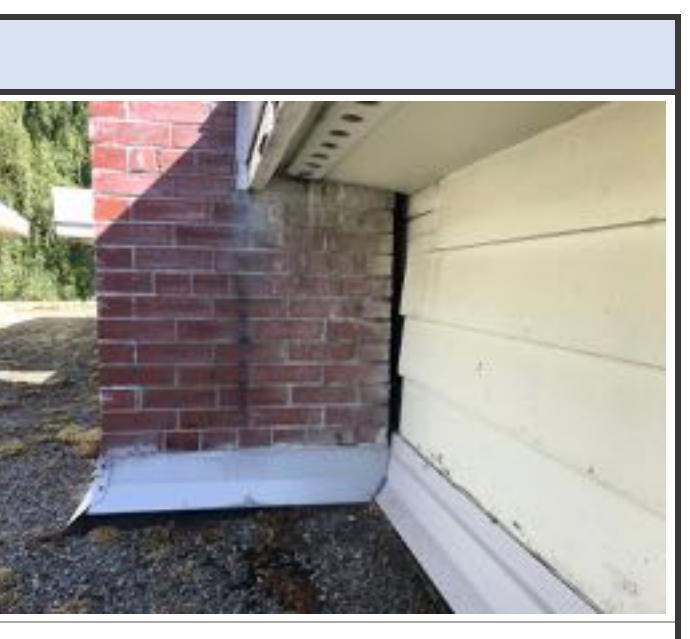
Photo 7 – Poor painted wood siding wall-to-brick chimney interface detail

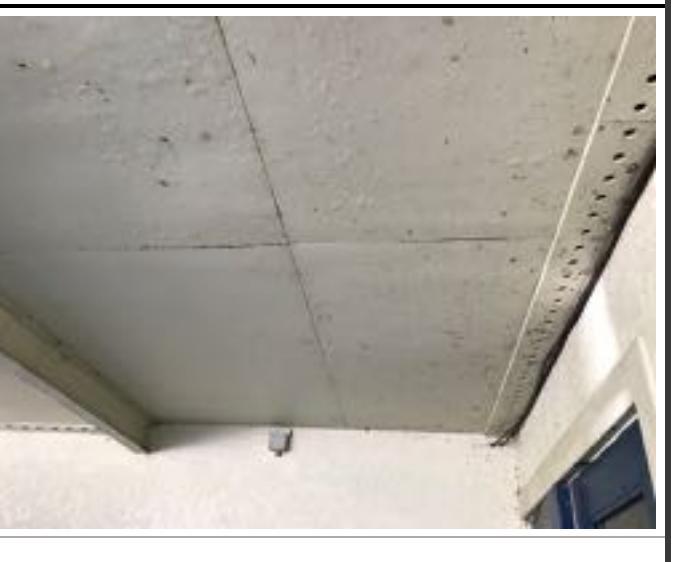
Photo 10 – Moisture and microbial growth on painted wood soffit

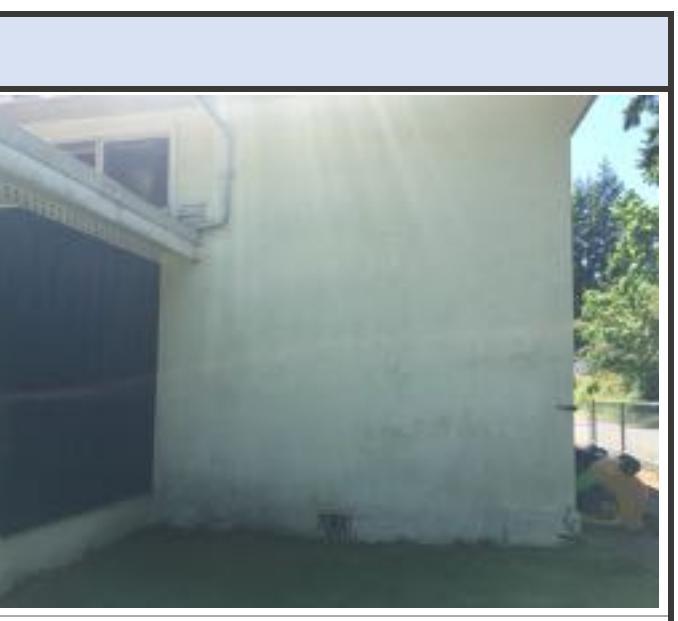
Photo 13 – Stains on stuccon wall

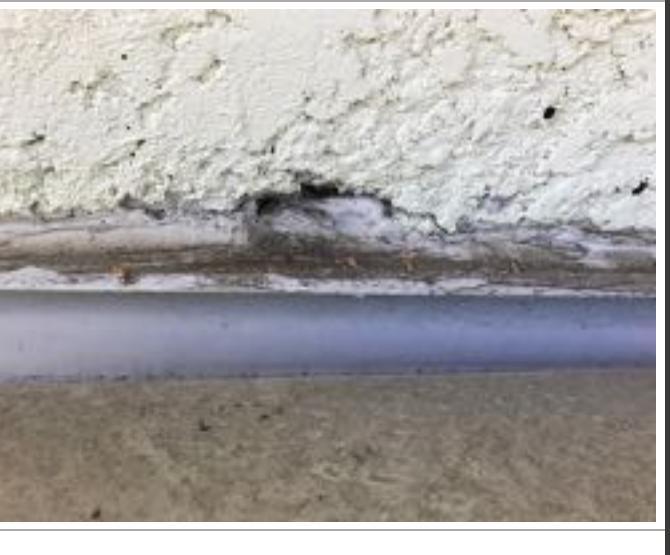
Photo 16 – Opening in stucco and sealant at a roof-to-wall interface

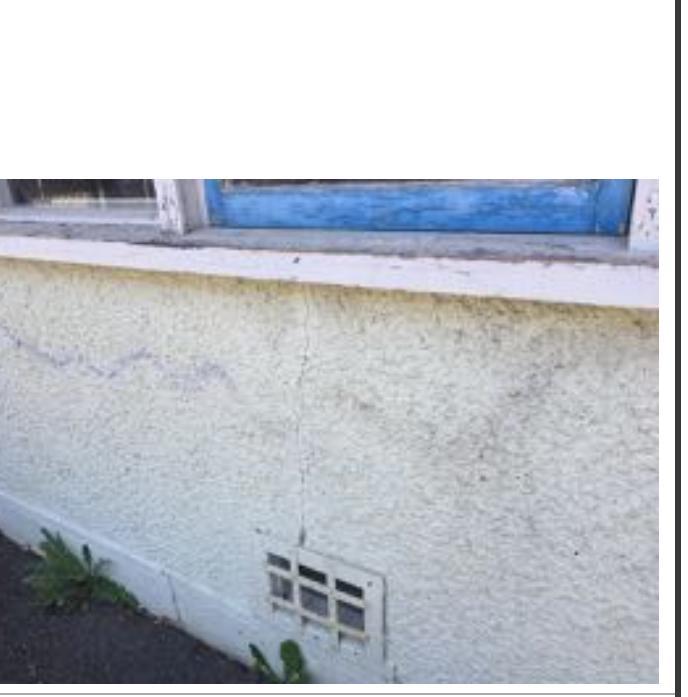
Photo 19 – Hairline crack, stains, and deteriorating stucco coating

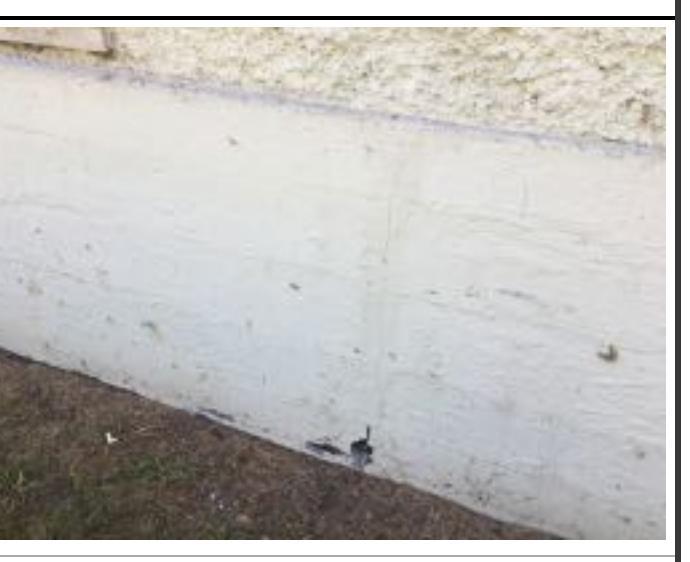
Photo 22 – Hairline cracks in foundation wall and coating

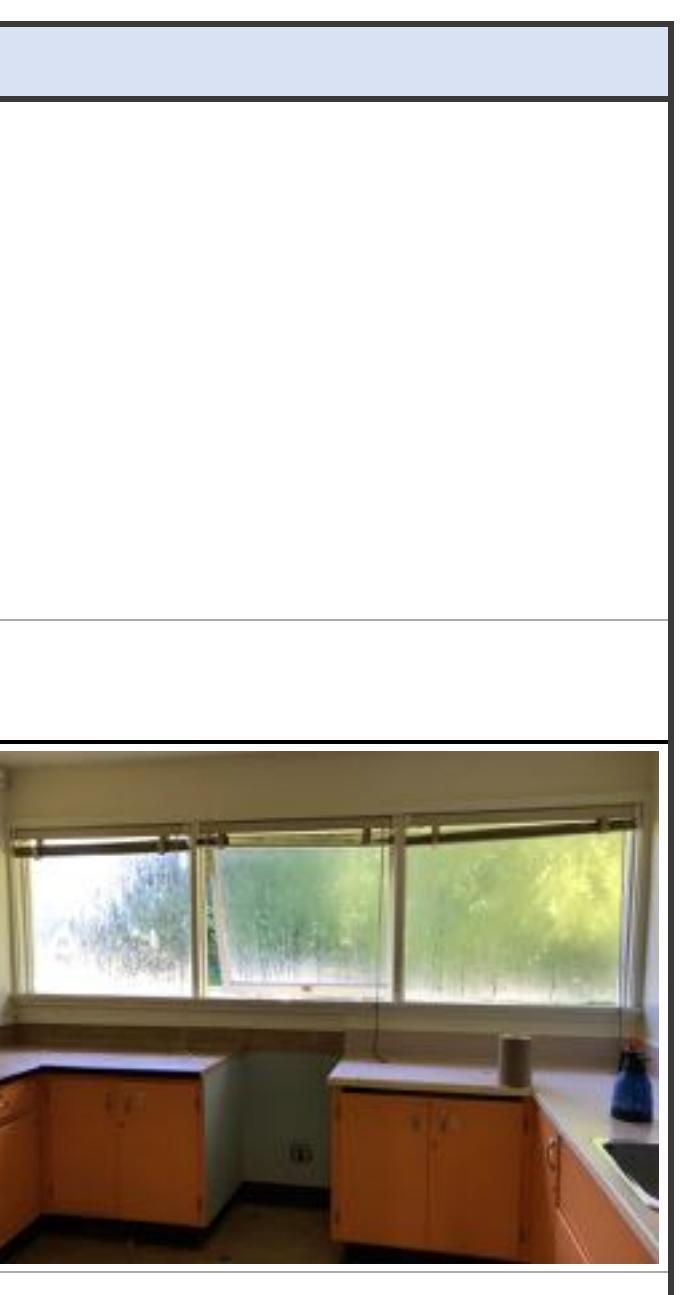
Photo 26 – Condensation on window panes inside gymnasium

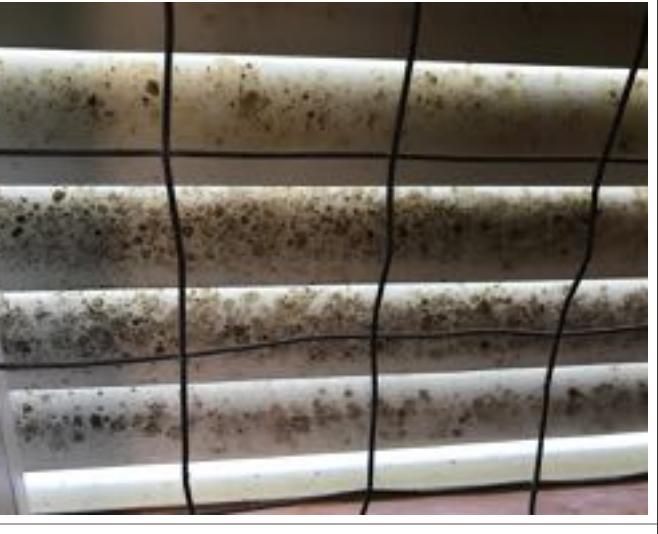
Photo 32 – Close up of microbial growth on window coverings

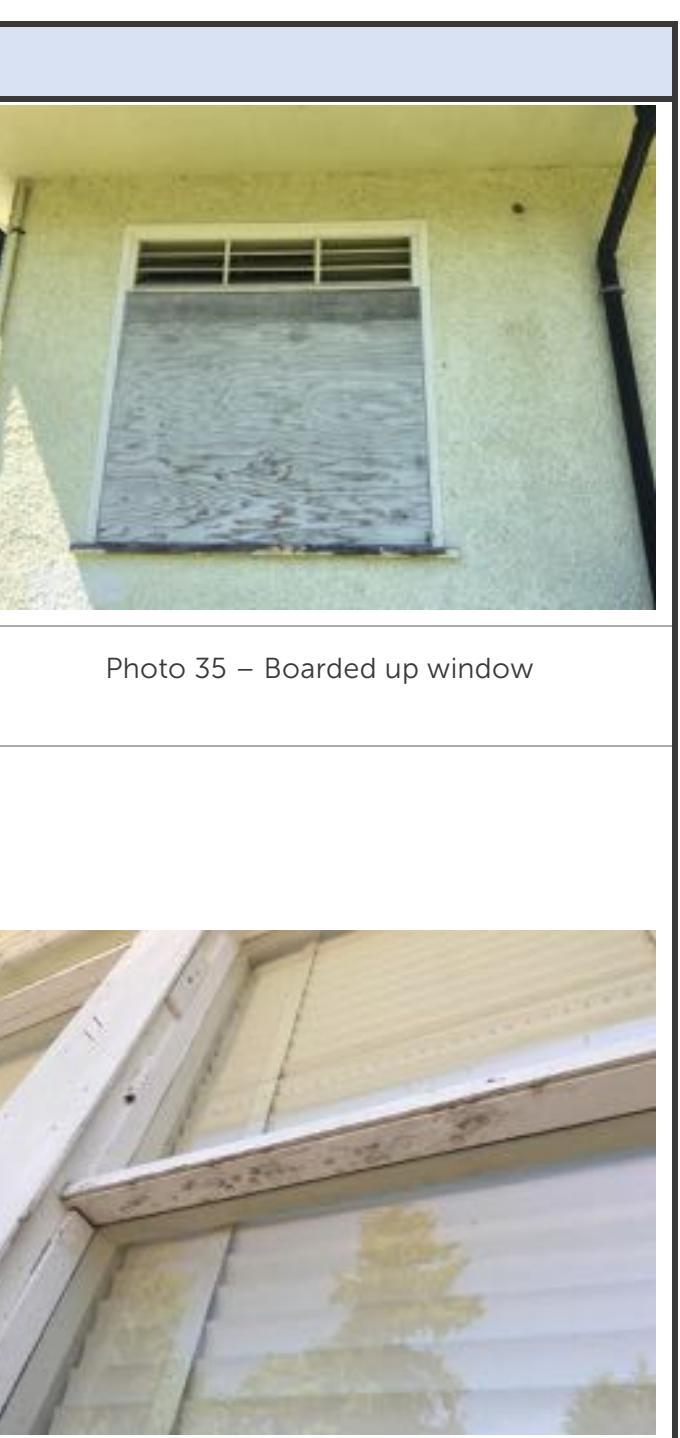
Photo 38 – Staining and microbial growth on window frames

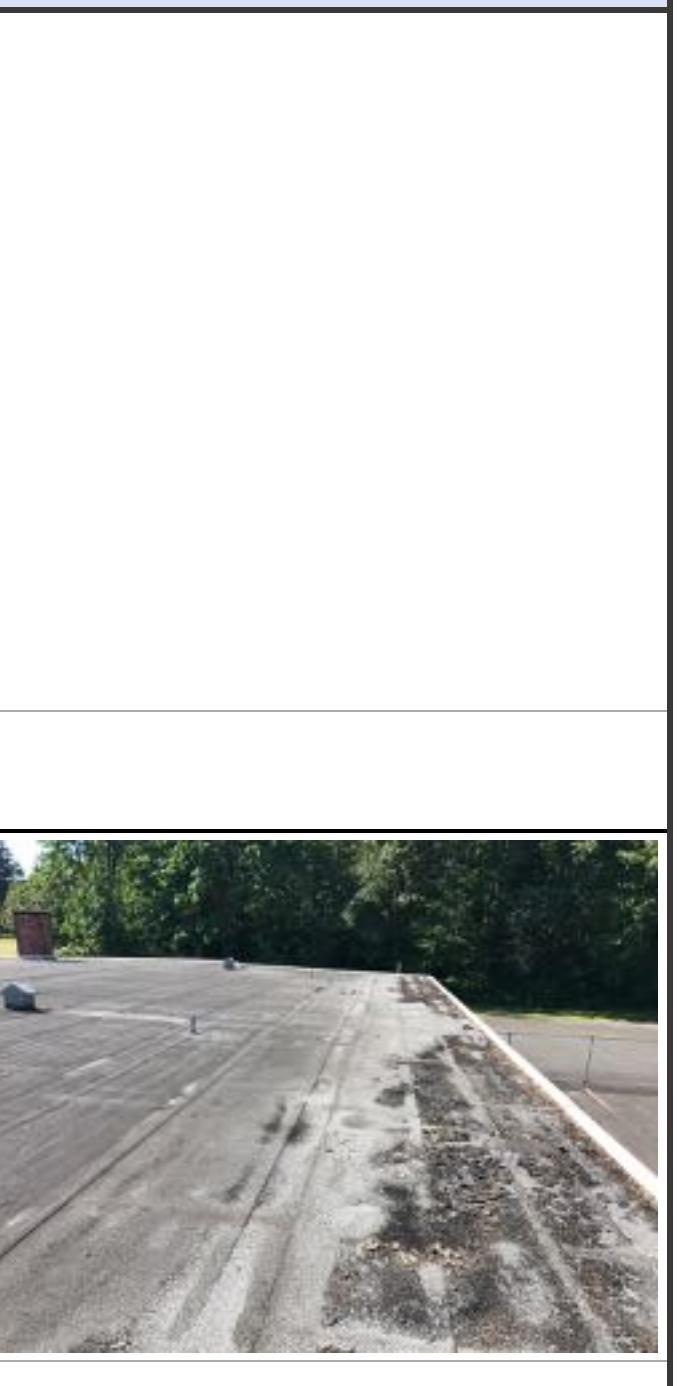
Photo 45 – Staining and collection of debris on roof surface

We recommend all the roofs be replaced as soon as possible. Estimated renewal cost is in the range of \$682,000.

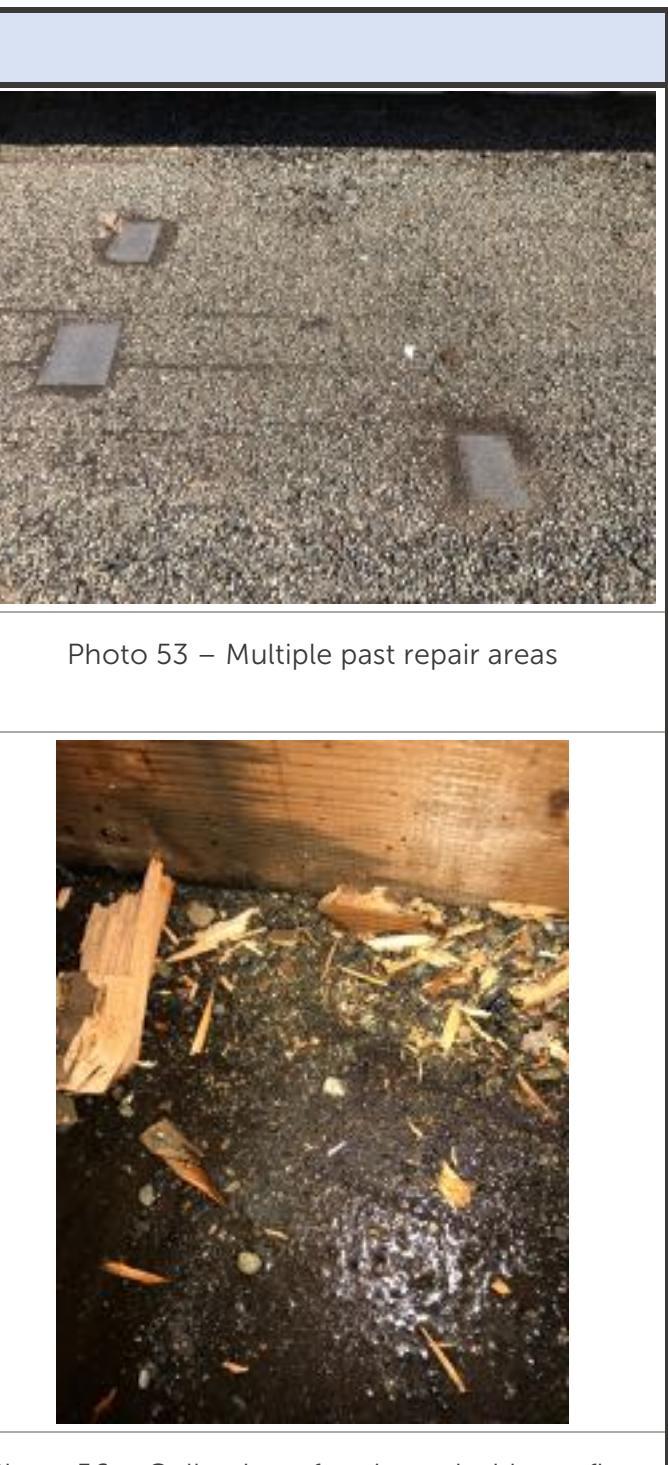
Photo 56 – Collection of moisture inside roofing assembly at gymnasium canopy

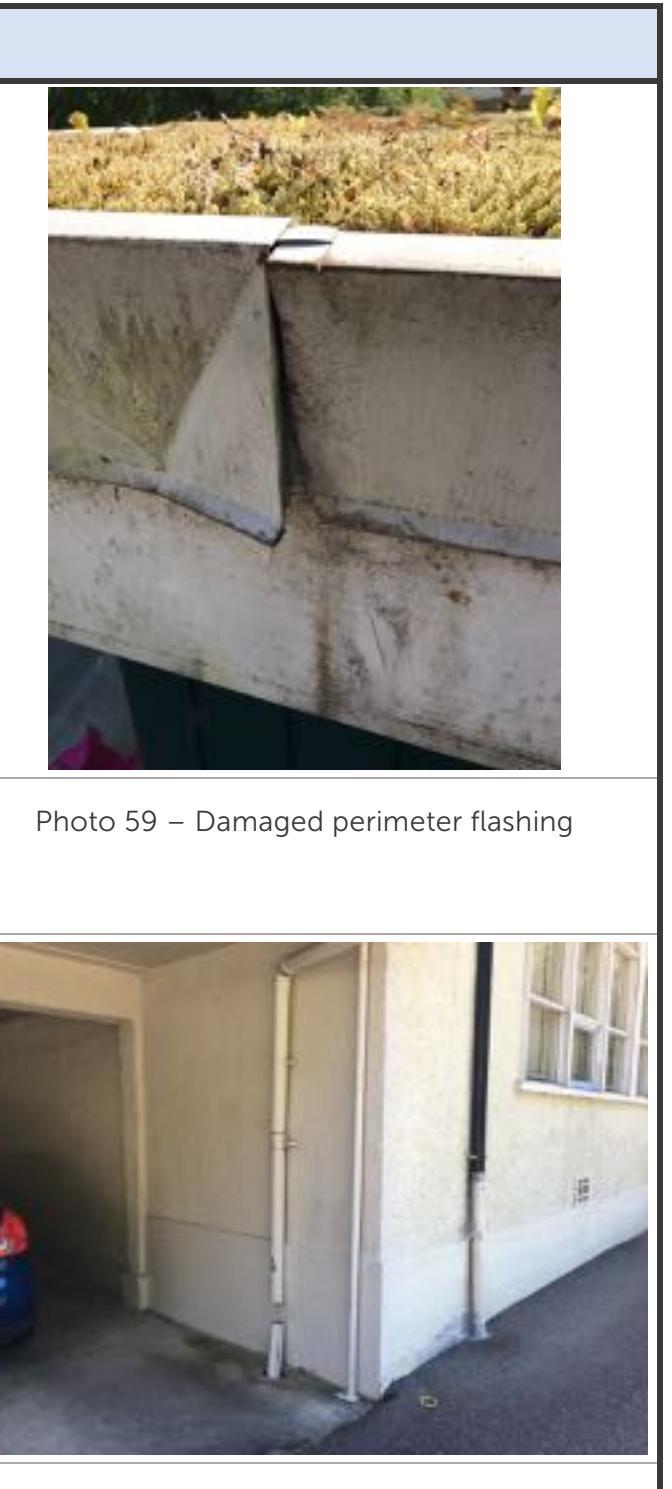
Photo 62 – A disconnected rainwater leader; different rainwater leader materials

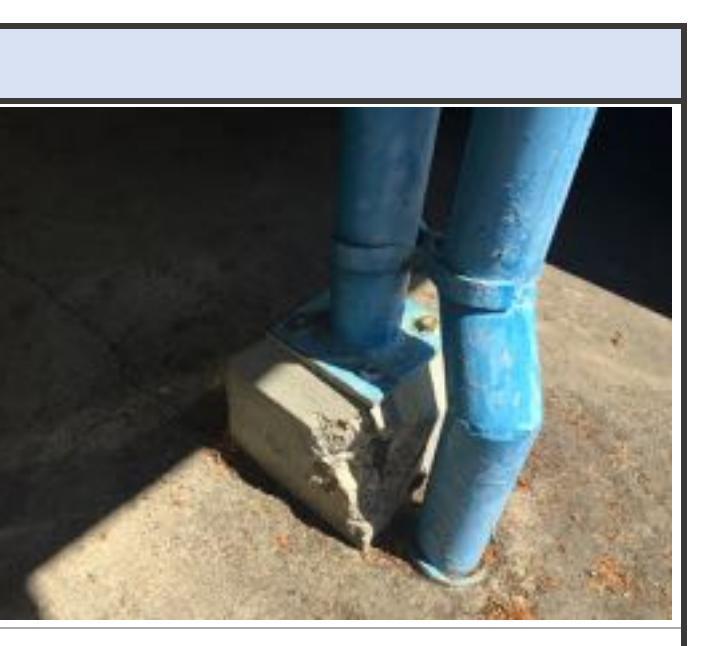
Photo 65 – Damaged concrete column base under gymnasium canopy

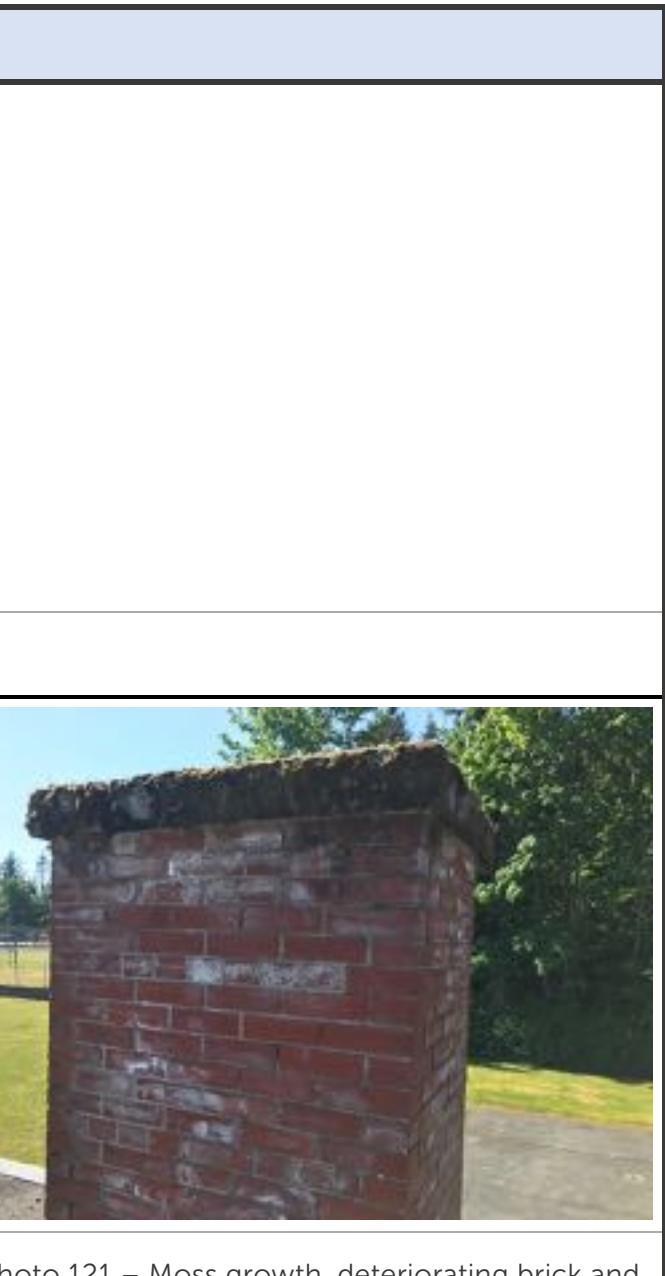
Two chimney vents constructed with bricks and mortar provide ventilation for the furnace equipment. The chimneys appeared to be in fair condition with efflorescence, moss growth, hairline cracks, and deteriorating sealants and flashing at roof-to-chimney interfaces. Depending on the building's future needs, these chimneys should be reviewed in detail, any deficiencies noted should be addressed and bricks and mortar should be re-pointed as required.

Photo 121 – Moss growth, deteriorating brick and mortar, and efflorescence found on chimney
