FACILITY CONDITION ASSESSMENT SALTAIR COMMUNITY CENTRE

3850 South Oyster Road, Ladysmith British Columbia

Prepared for:	Austin Tokarek, Asset Coordinator Engineering Services Department Cowichan Valley Regional District 175 Ingram Street Duncan, BC V9L 1N8
Prepared by:	McCuaig & Associates Engineering Ltd. #201 – 33 East 8th Avenue Vancouver, BC V5T 1R5
Date:	July 21, 2017
McCuaig Ref.:	20170401-C-RPT-FCA-01-FNL

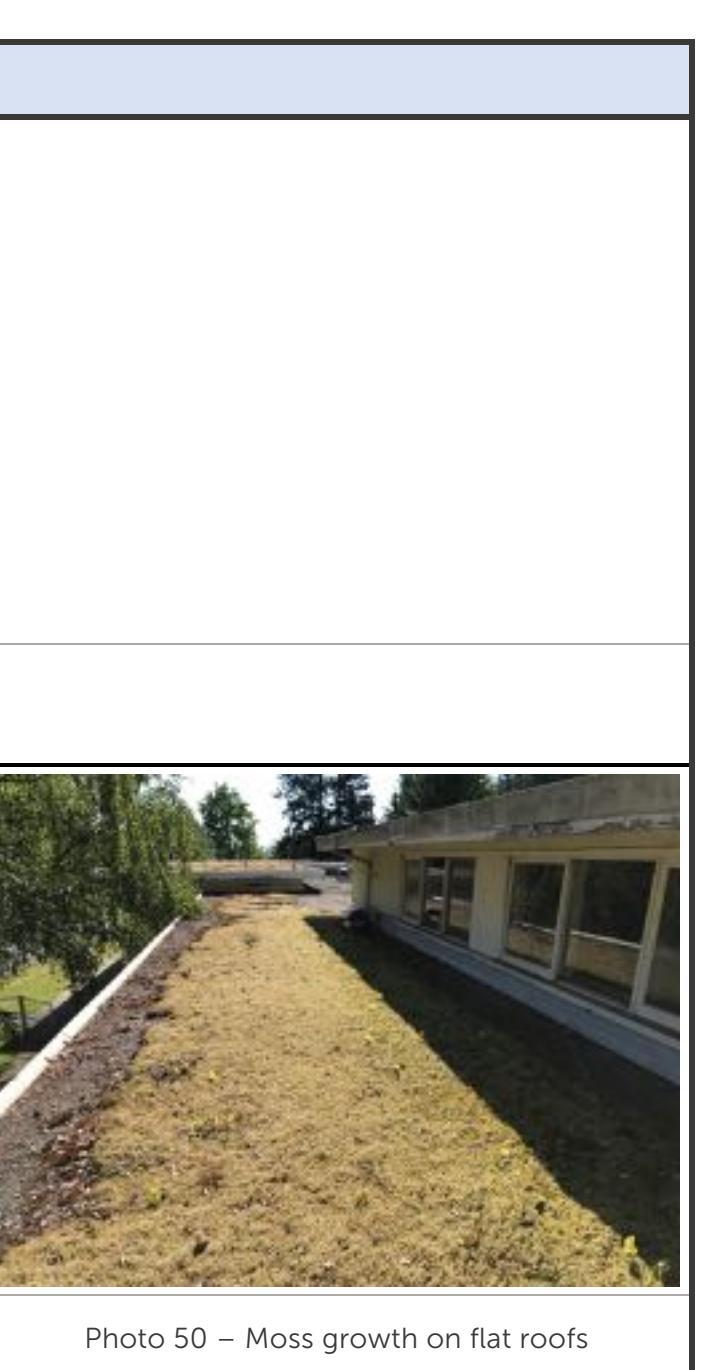
The roofs provided at SCC are predominantly low-sloped roofs protected with built-up roofing (BUR) and two-ply SBS membrane. The roofs appeared to be in poor condition with extensive moss growth, missing drain covers, evidence of multiple past repairs, deteriorating metal flashing and rainwater leaders, stains in ceiling and soffit finishes below, and bleeding, bubbling and alligatoring in the SBS cap sheet.

UNIFORMAT	COMPONENT		COMPONENT PHOTOS & DEFICIENCIES
B30 – Roofing	Flat Roof – SBS (continued)		
		Photo 46 – Alligator cracks and bubbling in SBS cap sheet	Photo 47 – Damaged and corroded mechanical vent
B30 – Roofing	Tar & Gravel Roofing		
		Photo 48 – An overview of tar & gravel roofing	Photo 49 – Extensive moss growth on sloped roofs

We recommend all the roofs be replaced as soon as possible. Estimated renewal cost is in the range of \$682,000.

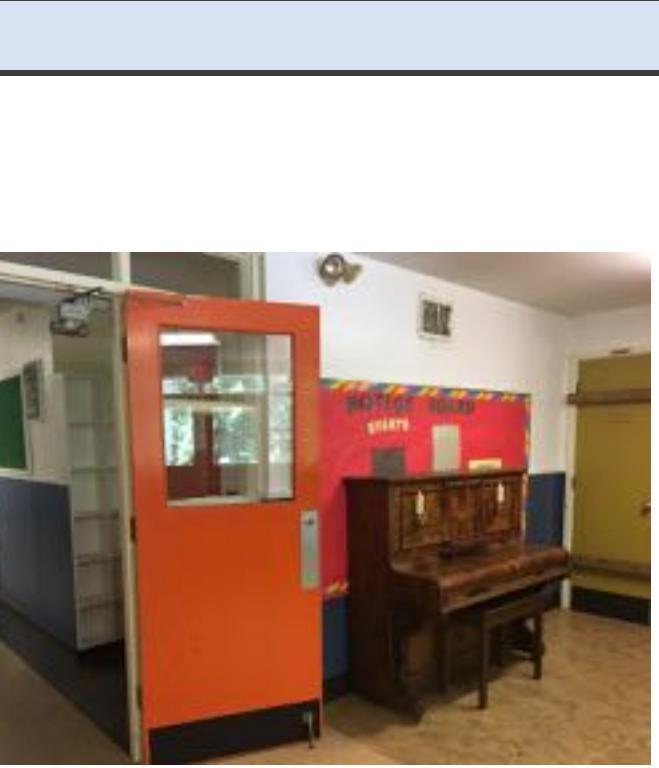
Photo 73 – Metal swing doors with glazing inserts near main entrance

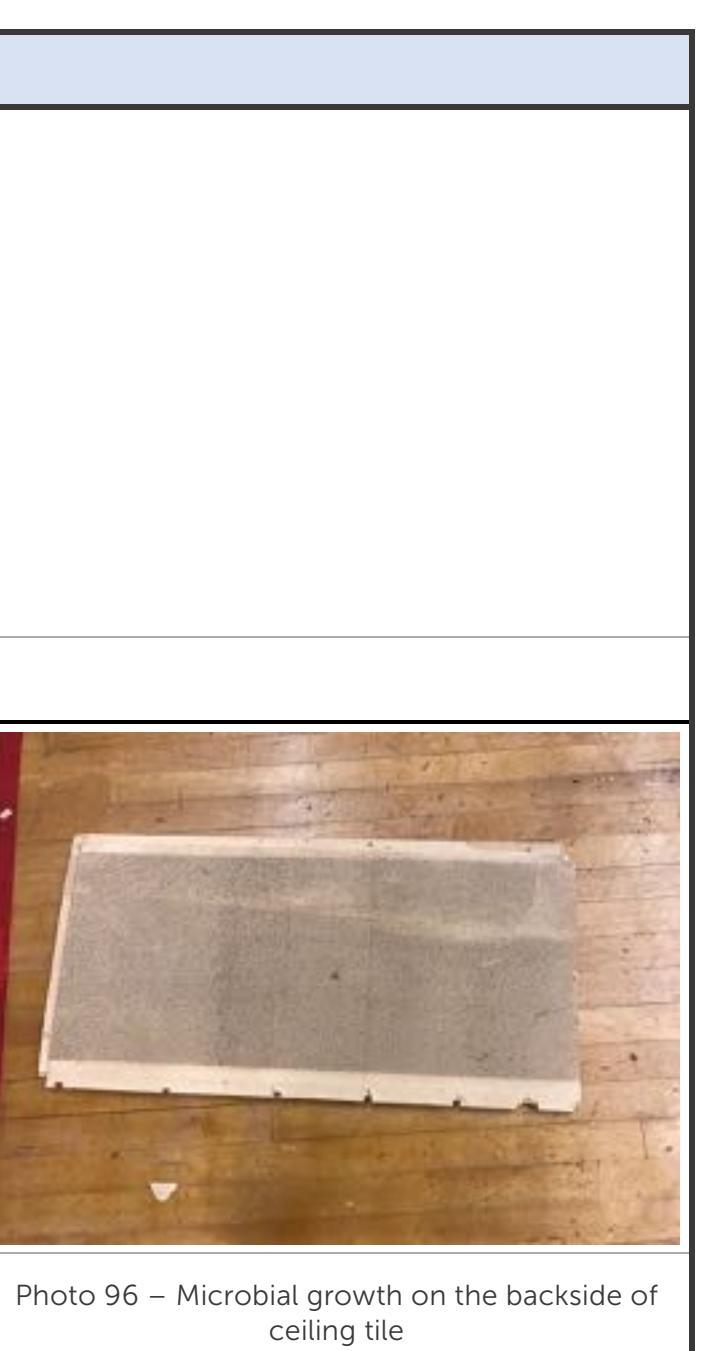
SCC contains nine classrooms, a gymnasium, three mechanical rooms, five washrooms, and various other work/storage spaces. The gymnasium is currently closed off due to water damage and falling ceiling tiles.

UNIFORMAT	COMPONENT		COMPONENT PHOTOS & DEFICIENCIES	
C3030 – Ceiling Finishes	Acoustic Ceiling Tile at Library 6	Photo 93 – Acoustic ceiling tiles at Library 6		
C3030 – Ceiling Finishes	Fibreboard Ceiling Tile at Gymnasium	Photo 94 – Bulging and sagging tiles throughout gymnasium	Photo 95 - West gymnasium ceiling where multiple ceiling tiles have fallen off	P

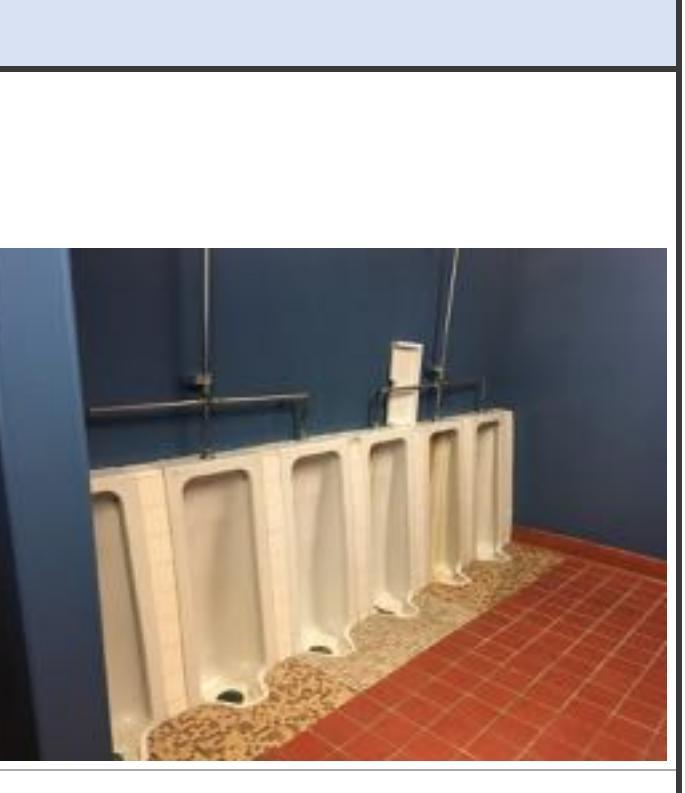
Photo 103 – Typical urinals in Boys Lav

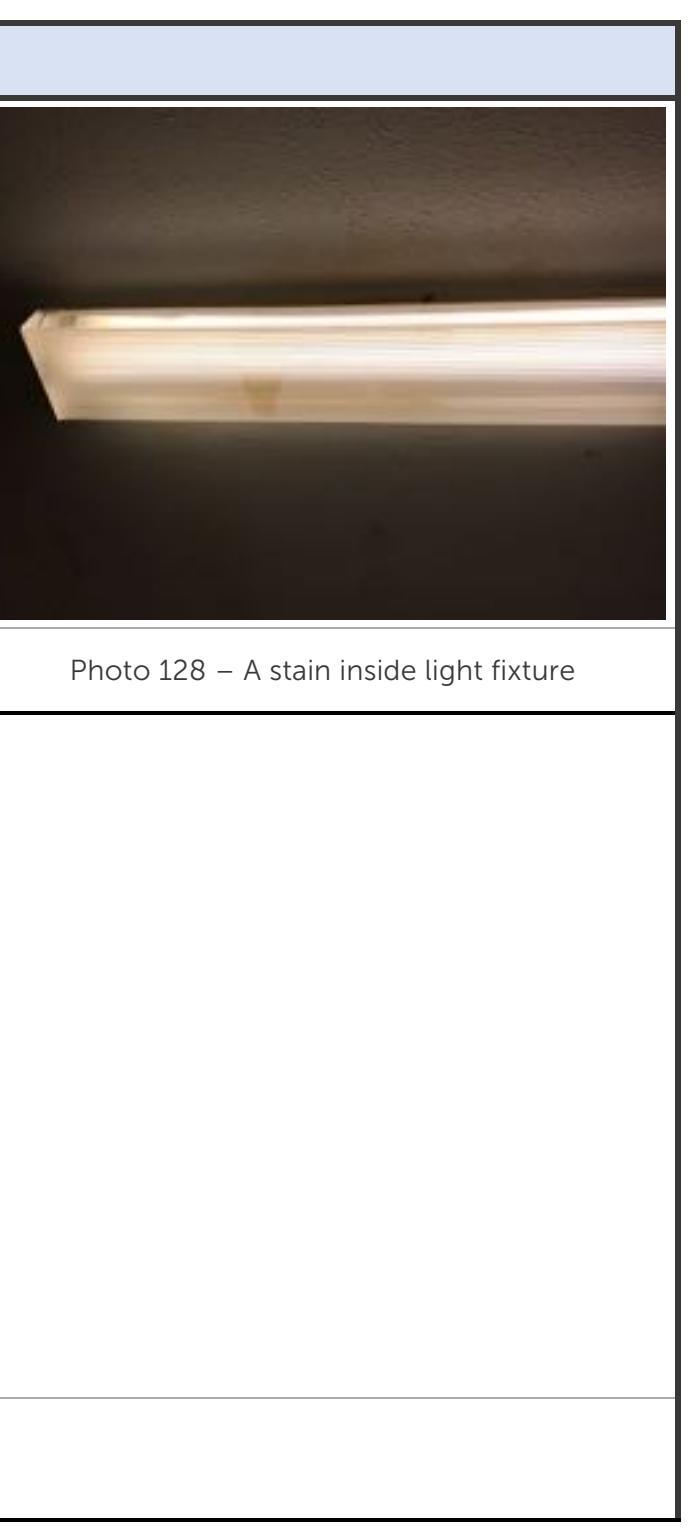
UNIFORMAT	COMPONENT		COMPONENT PHOTOS & DEFICIENCIES
D5022 – Lighting Equipment	Interior Light Fixtures		
		Photo 126 – Typical fluorescent lights	Photo 127 – View of T-8 fluorescent tubes
D5022 – Lighting Equipment	Exterior Light Fixtures	Photo 129 – Typical exterior wall mounted light	Photo 130 - A broken exterior light overlooking fenced play area
